# Pellicon<sup>®</sup> 2 Maxi Filter

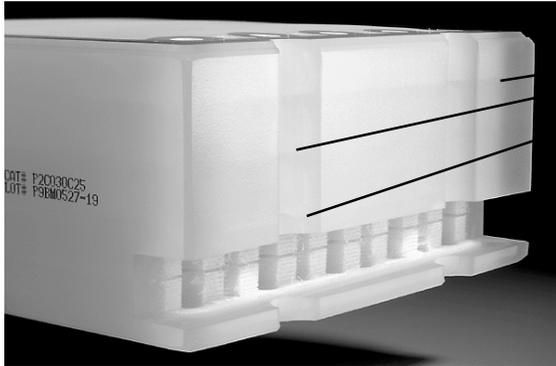
The lines in this photo that appear to be faults in the polyurethane jacket of the Pellicon 2 Maxi filter are actually the interface between components of the filter. These lines are a visual characteristic, not a functional concern.

Pellicon 2 2.5 m<sup>2</sup> Maxi filters are manufactured by assembling five 0.5 m<sup>2</sup> Pellicon 2 cassette filters in a stack. This stack of cassettes is then placed in a mold in which the outer layer, or jacket, of polyurethane is formed. Once the jacket is formed, it is possible to see the interface between the outer jacket and the beveled edge of the 0.5 m<sup>2</sup> Cassette through the translucent adhesive. This interface appears as a line, sometimes thought to be a crack.

This interface line is a visual characteristic of the device. It is the result of the manufacturing process. It is not a defect. There is some variation which results in the line appearing to differing degrees but in no case is it a functional concern.

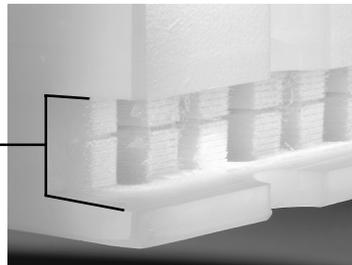
*This cutout exposes the inner construction of a Pellicon 2 Maxi cartridge. Light reflection caused by these lines is often misinterpreted as a crack. These lines are a visual characteristic, not a functional concern.*
